Bridge Inspection Program

Bridge Loc. No. 71-SR056-0.54

BRIDGE EVALUATION REPORT

Route: SR-56 (Smithville Hwy.)
over I-40

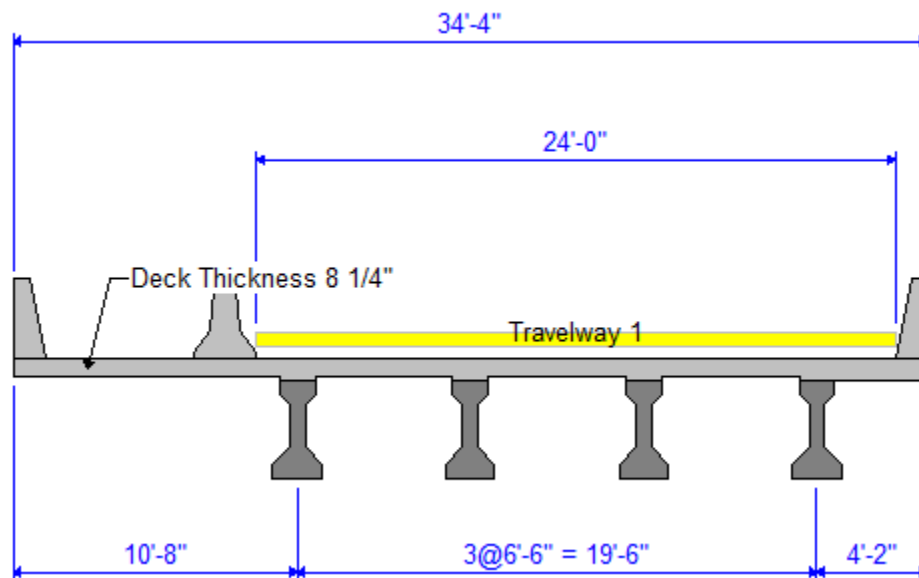
1. Beam "A" in Span 1 is severely damaged and has been partially removed. In its current condition, it has no dead load or live load carrying capacity.
2. Beam "B" in Span 1 has minor spalls and heavy smoke stains but has no exposed prestressing strands or reinforcing steel. This beam was sounded throughout with an inspection hammer and no delamination was found.
3. The stay-in-place metal formwork on the bottom of the deck in Bay "A" of Span 1 has distortion and heat damage caused by the fire underneath the bridge.
4. In the most recent routine inspection report, the remaining beams are noted as having areas of minor concrete scaling and spalling, as well as hairline cracks.
5. In the most recent routine inspection report, the bearing devices at both abutments are noted as having section loss up to 1/16 inch deep.

1. Close a portion of the deck in Span 1 in order to shift live load traffic away from Beam "A". This can be accomplished by placing a portable concrete barrier as shown in the sketch below. (Please note that Beam "A" is removed in the sketch.)

2. Install temporary shoring underneath the remaining portion of Beam "A" in Span 1.
3. Replace Beam "A" in Span 1. This will include replacing the left cantilever and Bay "A" of the concrete deck in Span 1.
4. Repair areas of concrete deterioration throughout the remaining beams.
5. Clean and paint the bearing devices at both abutments, including replacing anchor bolts and nuts if necessary.
6. Level the riding surface at both approaches.
